## MISSING BEVEL ON 522 UPPER STEM

### Potential Issue with High Pressure Control Valve Upper Stems

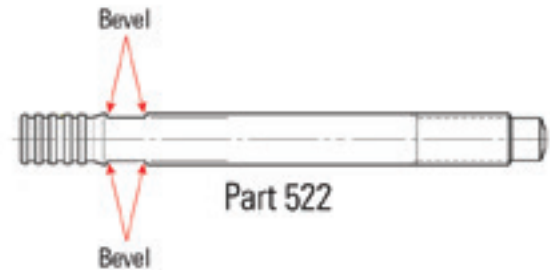
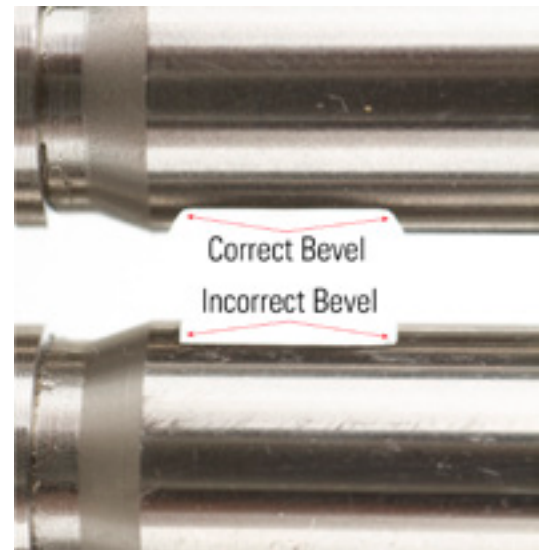
We've recently discovered a potential issue on our 2" High Pressure Control Valve. The valve is missing a bevel located above and below the wrench flats on the 522 upper stem. This lack of a bevel can cause damage to the o-ring when it's installed.

The potential operational issue this could cause is a leak of supply gas.

We recommend that you immediately inspect your inventory and any active valves that were shipped after June 26th, 2019 for this defect.

Products manufactured after July 23rd, 2019 have had this issue corrected.

If you discover any affected products, please contact your local authorized distributor or Kimray store with the number of replacement parts you need.
