We've recently discovered a potential issue with the D-shaped hub connection in our **Mechanical Dump Valves and Trunnions**. The tolerances applied to the newly designed hub-to-shaft (or hub/shaft) connections were too loose, allowing for greater play at this D-shaped connection than is ideal.

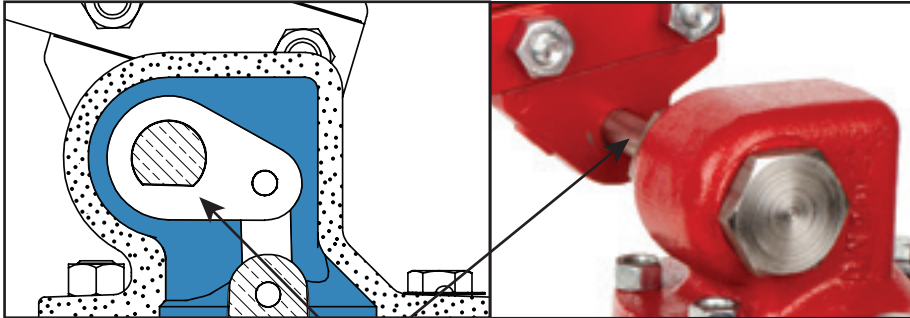
HUB-TO-SHAFT CONNECTION

Specifically, as the float reaches its fully UP position, this might not be enough to fully open the valve, due to the amount of play in the D-shaft/hub connections. This is a potential performance issue, not a safety issue.

We have quickly corrected this issue by tightening the tolerances (making the shaft dimensions larger).

The solution for affected valves and trunnions is to replace the shafts with new shafts that have a larger dimension, as mentioned above.
