LEVER OPERATED LIQUID DUMP VALVE

This product notice is to inform you of a material change in a fastener in our Lever Operated Piston Balanced Throttling Liquid Dump Valves.

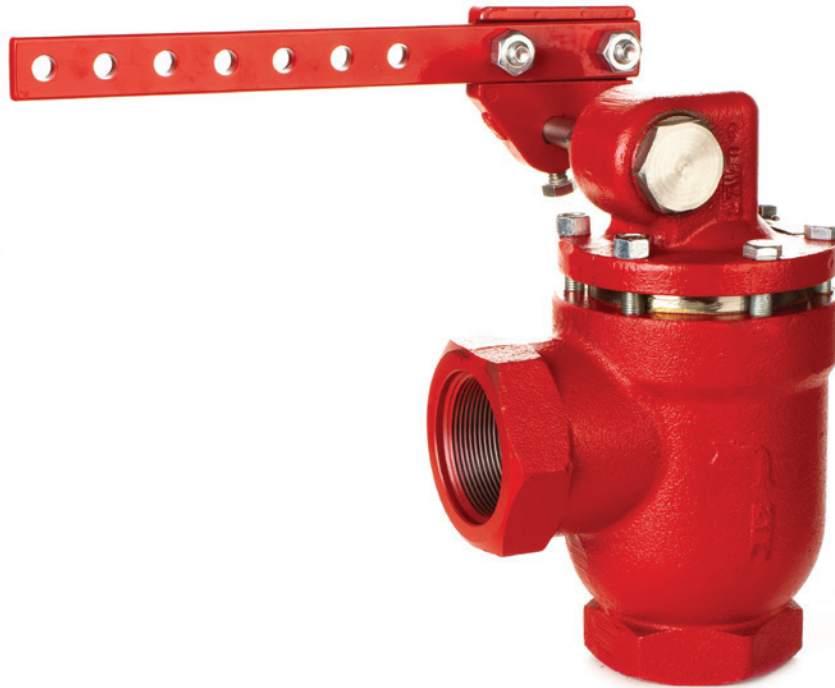
We have received reports that in a few applications the zinc-plated lock nut that holds the seat to the stem has corroded and come off. Due to this, we have changed this zinc-plated lock nut to a Stainless Steel lock nut.

The new lock nut P/N is 173SS6, replacing the 173 lock nut.
